## Cottage Restoration

# Visit the CRUCK COTTAGE

## Torthorwald Dumfries & Galloway

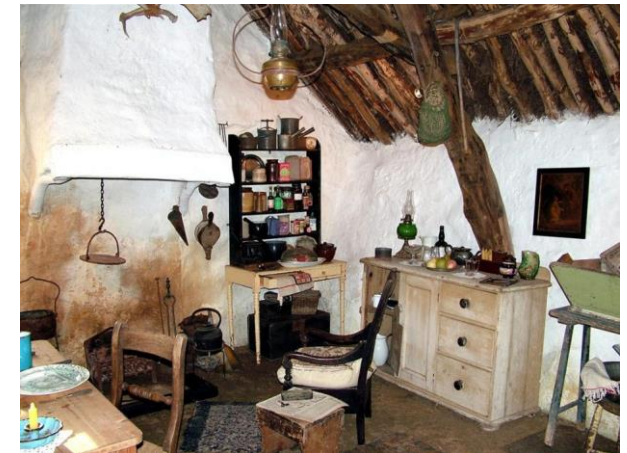
The cottage is typical of those built in the early years of the 19th century. It is 'But and Ben' type and is an 'improved' cottage, though to the modern eye it still appears to be very basic. The kitchen was at the west end by the hanging Lum (chimney), most of the family activity would have taken place here close to the ever-present fire.

The cruck-tree was probably used to hang cooking pots. Smoke would have wafted into the cottage and hung heavily around the rafters. This must have been unpleasant, but helped to preserve the roof structure and reduce the numbers of mice and insects living in the thatch. The fire-place at the other end of the building was probably put in when the cottage was rebuilt last century.
